# Reassessment of the Vegetation of the Nonquitt Salt Marsh

University of Massachusetts Dartmouth

Report Submitted to the  
Dartmouth Natural Resources Trust  
June 1, 1999

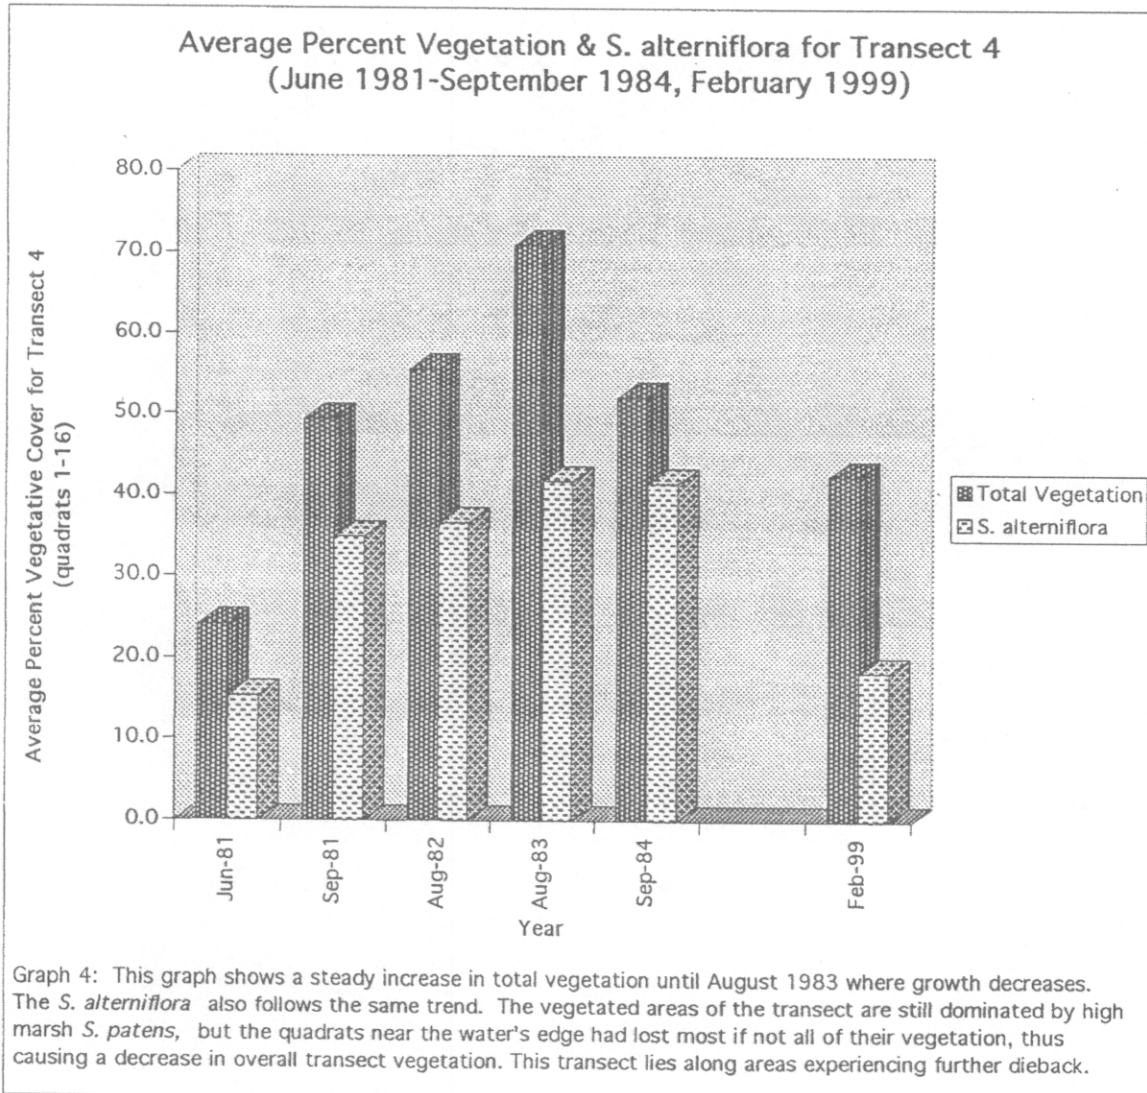
*Table A: Transect #A*

Graph 4: This graph shows a steady increase in total vegetation until August 1983 where growth decreases. The *S. alterniflora* also follows the same trend. The vegetated areas of the transect are still dominated by high marsh *S. patens*, but the quadrats near the water's edge had lost most if not all of their vegetation, thus causing a decrease in overall transect vegetation. This transect lies along areas experiencing further dieback.

**Transect 4:** Transect 4 extends for thirty-two meters with sixteen quadrats. This transect has shown a gradual increase in total vegetation cover from 1981 to 1983, but in 1984, and again by 1999, the total vegetation decreased (Table and Graph 4). Despite these declines, total vegetation cover increased 79% between 1981 (24% cover) and 1999 (43% cover). *S. alterniflora* experienced the same trend along this transect. The data show that the small amounts of vegetation that had begun to colonize the outer quadrats of the transect near the bay between 1981 and 1984 had disappeared by 1999. The overall increase of vegetation occurred in quadrats previously supporting stands of the two dominant marsh grasses.

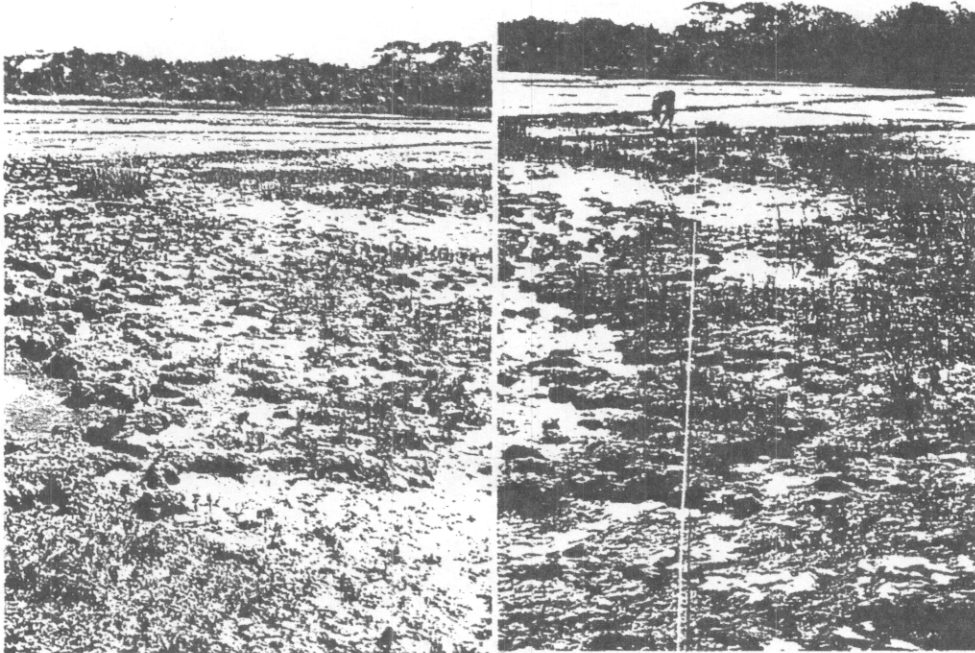
Figure 7: Established in 1983 on a nearly barren area of marsh peat previously vegetated, the area was colonized mostly by *Salicornia* in 1983 and 1984, but by 1999, as in Transect #6, all vegetation was gone and further erosion of peat had occurred.

**Transect 7:** Transect 7, established in 1983, is a thirty meter (fifteen quadrats) line located near transect 5. Vegetation which was sparsely scattered along this transect in 1983 (51% cover) was completely gone by 1999 (Table and Graph 7). The peat in this area has become extensively eroded in 1999. Peat erosion already had begun when the photographs were made in 1984 (Figure 7).

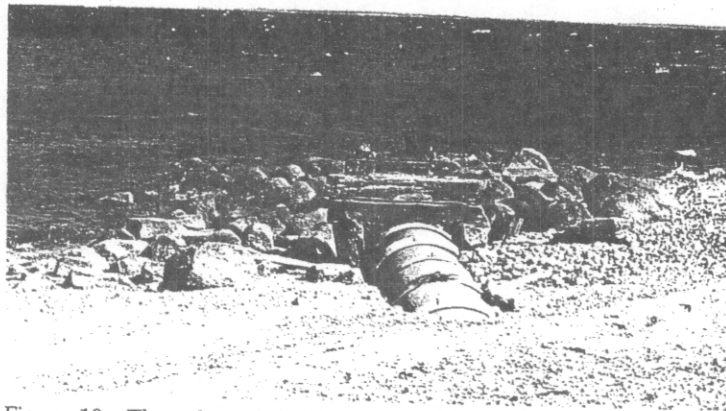
Figure 10: The culvert pipe that runs from the open channel to the bay is currently the major restriction to tidal exchange. This restriction will have to be rectified before there is much hope of the marsh becoming re vegetated with it's natural saltmarsh grasses.

Tidal restrictions still exist in the channel connecting the marsh to Buzzards Bay. The 30" diameter culvert severely restricts tidal exchange, as does the shallowness of the open part of the channel that has rip-rap on the bottom and along the sides. It may be that over the years the large granite blocks at the bottom of that open channel have been lifted from ice causing further obstruction to tidal exchange. This granite "shelf" may not have been present when the blocks were initially layed. Even with careful maintenance to remove accumulated sand and gravel there, the granite blocks lining the bottom of the channel prevent total drainage of the marsh during low tides. To bring a natural tidal exchange to the marsh both of these obstructions will have to be removed or replaced.

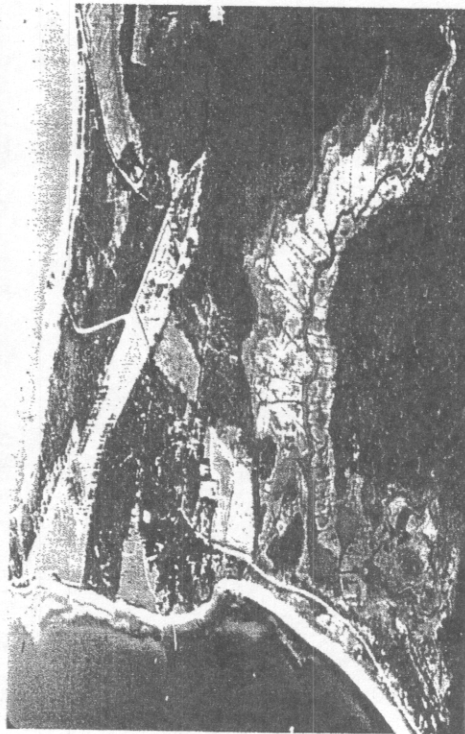
Figures 18 and 19 Aerial views of the Nonquitt salt marsh in 1981. At that time 60% of the marsh vegetation had died, exposing the peat to erosion. Straight lines are ditches dug by a machine earlier to help control mosquito populations. When healthy, all of the entire marsh except for the creeks would have been covered by the marsh grasses *Spartina patens* and *Spartina alterniflora*. The reddish-brown areas are populations of the annual *Salicornia europaea*.

Tabulated and graphed data for transects 1-9 are given in Tables and Graphs of corresponding transect numbers. There was total loss of vegetation along transects 5-7, but previous data are presented for these transects in Tables and Graphs 5-7. Photographs from 1981, and/or 1982, 1984 and 1999 of transects 1-9 are given in Figures 1-9. Additional photographs taken in March, 1999 are given in Figures 10-17 and 20-21. Aerial views taken in 1981 of the Nonquitt marsh are reproduced in Figures 18 and 19.
